Contract #: 04-0120F4Cty: SF/ALA Rte: 80 PM: 13.2/13.9File #: 69.28**WELDING INSPECTION REPORT****Resident Engineer:** Pursell, Gary**Address:** 333 Burma Road**City:** Oakland, CA 94607**Report No:** WIR-001537**Date Inspected:** 24-Feb-2008**Project Name:** SAS Superstructure**OSM Arrival Time:** 800**Prime Contractor:** American Bridge/Fluor Enterprises, a JV**OSM Departure Time:** 1730**Contractor:** Zhenhua Port Machinery Company, Ltd (ZPMC), Changxing Island **Location:** Shanghai, China**CWI Name:** Chen Xi**CWI Present:** Yes No**Inspected CWI report:** Yes No N/A**Rod Oven in Use:** Yes No N/A**Electrode to specification:** Yes No N/A**Weld Procedures Followed:** Yes No N/A**Qualified Welders:** Yes No N/A**Verified Joint Fit-up:** Yes No N/A**Approved Drawings:** Yes No N/A**Approved WPS:** Yes No N/A**Delayed / Cancelled:** Yes No N/A**Bridge No:** 34-0006**Component:** 89M mock-up/Deck Panel**Summary of Items Observed:**

Bay 1 - OGB Deck Panel (Gantry 1)

Tower Shop**89 Meter Mock-Up**

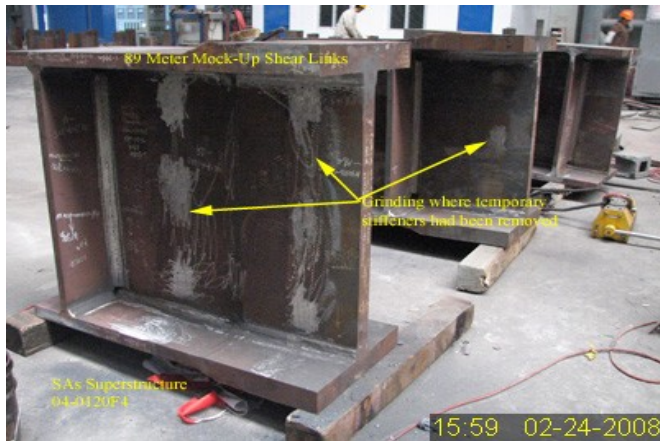
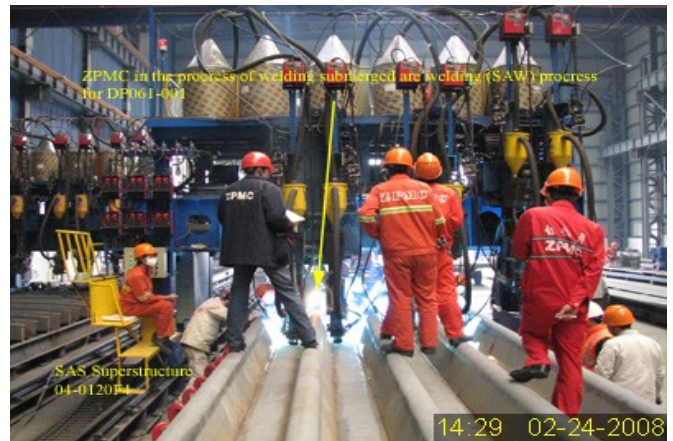
QA Inspector Brannon observed ZPMC personnel are continuing with manual drilling of the bolt holes at skin plate E for the Shear Link Beam in a skewed position. QA Inspector also, observed ZPMC personnel removing weld metal by method of grinding, area's for the Shear Link Beams where the temporary stiffeners had been

removed.

The following digital photographs below illustrates observation of the activities being performed.
